SUBJECT: STABILIZER TRIM STOP/SCREW MODIFICATION

MODEL/S/N AFFECTED: M20J - S/N 24-0001 THRU 24-1694 & 24-3000 THRU 24-3172  
M20K - S/N 25-0001 THRU 25-1230  
M20L - S/N 26-0001 THRU 26-0041  
M20M - S/N 27-0001 THRU 27-0058

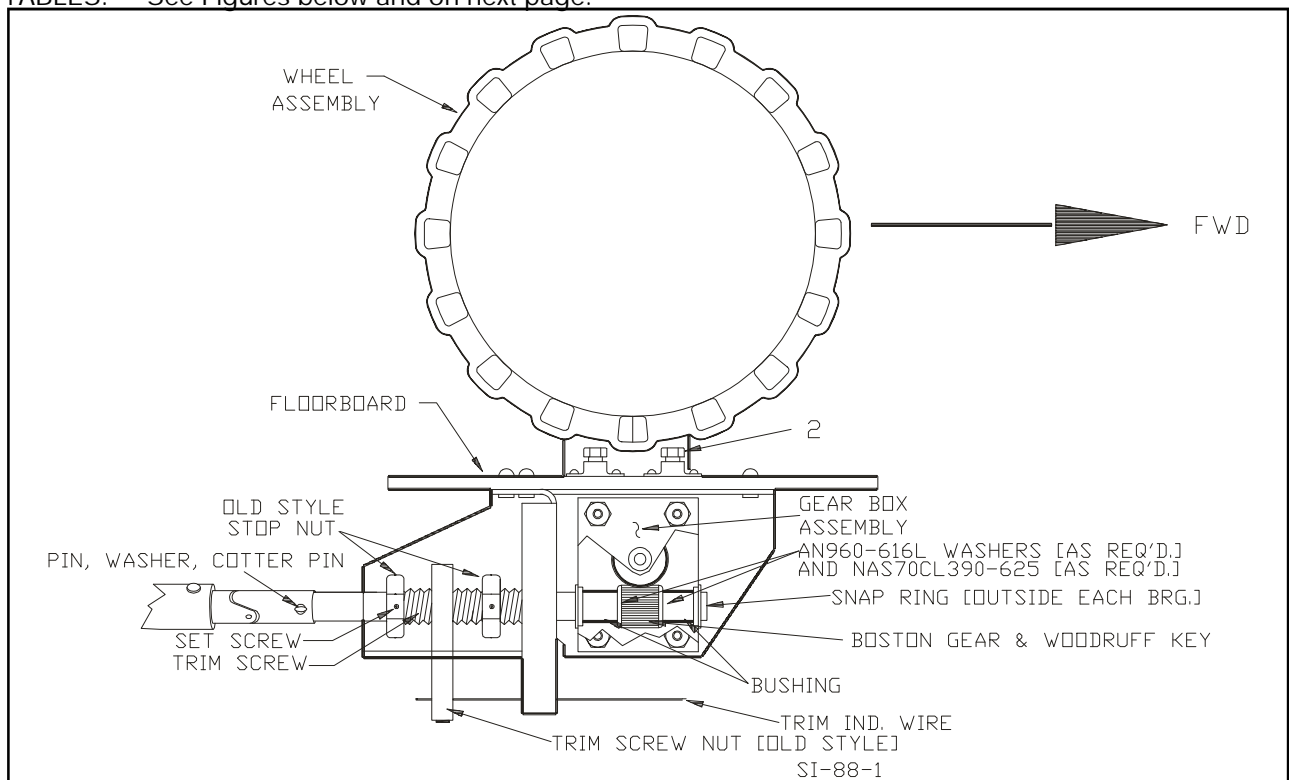
FIGURE SI M20-88-1

There have been occasions when the elevator trim control wheel has been manually turned to the extreme nose up or nose down condition and the electric trim system was unable to move the trim indicator nut off the stop at the next electrically activated command. Manual movement must be the initial action to get the trim indicator nut off the stop, then the electrical system will operate normally.

4. Remove cotter pin, washer and pin that secures trim tube universal joint to trim screw (Figure SI M20-88-1).
5. Loosen gear box bolts (Index 1, Figure SI M20-88-2) if not already done, and both NAS428-3-4 bolts (Index 2, Figure SI M20-88-2) to give slack in roller chain between upper and lower sprocket of trim control wheel assembly.

7. Remove roll pin, P/N RPA52-028-125-1125 holding lower sprocket, P/N 740049, to gear box shaft. Remove sprocket.
8. Loosen set screw, #6-32 x 1/8, in each existing trim stop so they will unscrew easily. Remove aft trim stop (DN stop) from trim screw (Fig. SI M20-88-1).

12. Measure and document lateral free play in trim screw shaft (length wise play) as assembled in the gear box assembly.
13. Remove forward snap ring from trim screw. Reference Figure SI M20-88-1
14. Lightly tap trim screw at forward end, with a plastic mallet, to drive trim screw, bushings, washers, gear and aft bearing from gear box assembly housing. Bearings are installed with locktite (Blue) at assembly, so some effort may be required to break it loose. **DO NOT DAMAGE BEARING NOR HEAT THE HOUSING.**
15. When existing trim screw, and components attached to it, comes free from gear box housing, the bushings, washers, gears, woodruff key, snap ring and aft bearing will be removed. Retain components, except woodruff key, to place back on new trim screw (Fig. SI M20-88-1).
